Urgent measures to repair flood damage to the L73 road

Slope stabilisation with TITAN micropiles

Urgent measures to repair flood damage on L73 road between Schuld and Insul, Germany

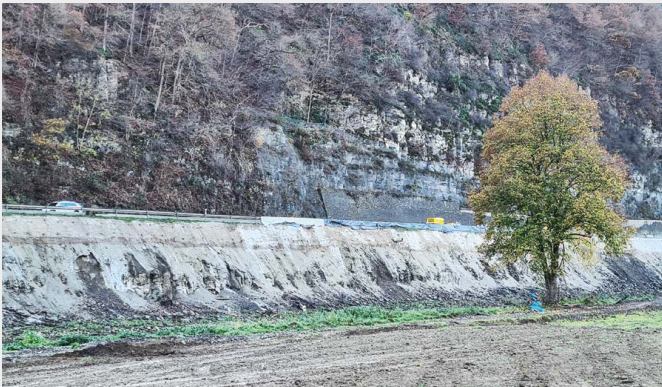
Anchors were installed to secure the slope over a length of about 400 m

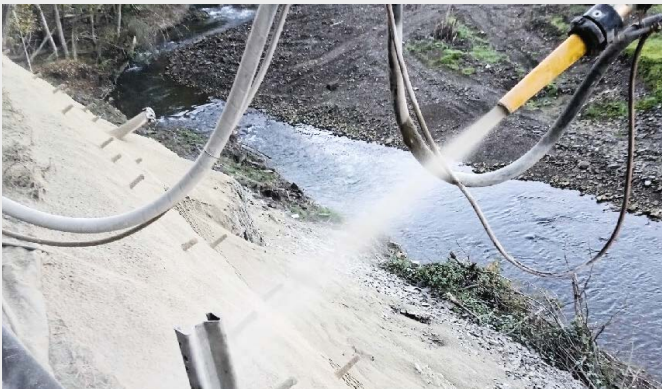
The shotcrete facing is 25 cm thick, up to 50 cm at craters

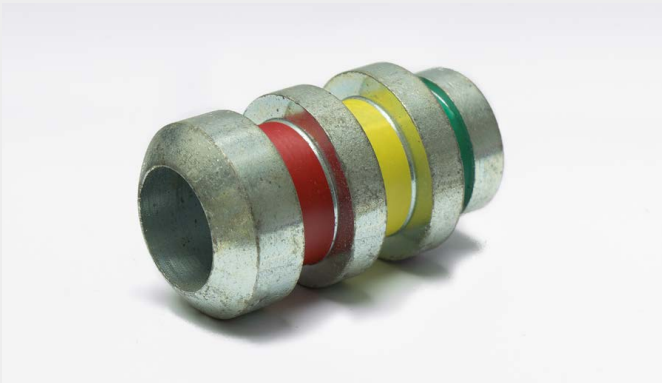
Load indicators were attached to the tops of the micropiles so that any movements of the slope are rendered visible

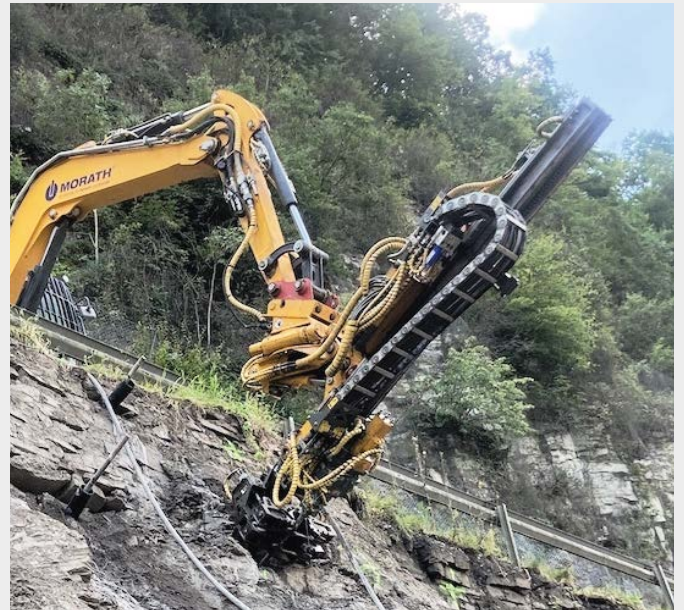
Only small, lightweight plant could be used, and could only work from above

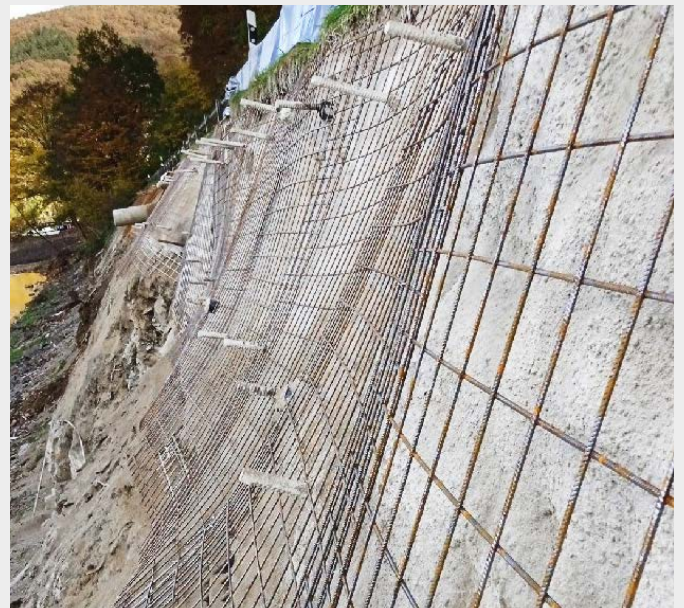
Reinforcement is in the form of two layers of steel mesh
